ZINGASPRAY FOR FLM

COMPILED BY: ANEESHA SACHDEV DIRECTOR OF BUSINESS DEVELOPMENT ZINGAMETALL SINGAPORE PTE. LTD.

FIMS 04 BULLETIN

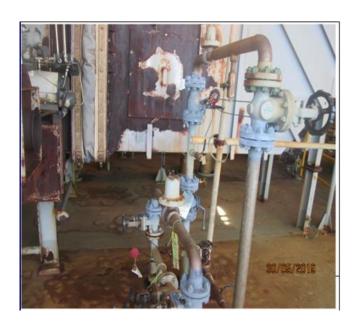
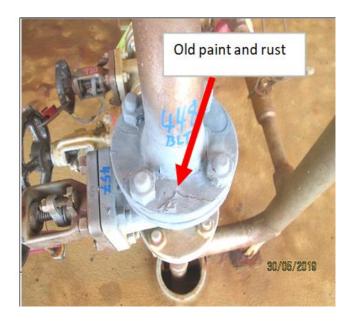
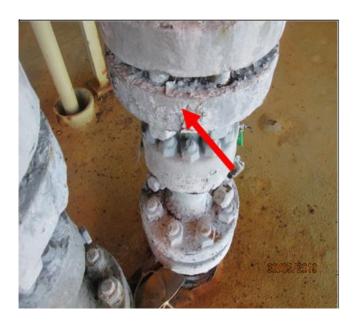
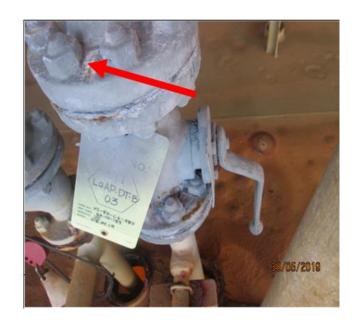
DESCRIPTION: ZINGA APPLICATION AS SHOWN BELOW IS NOT ADEQUATE — THE SURFACE PREPARATION IS NOT DONE TO A PROPER STANDARD SINCE LOOSE PAINT AND RUST

SCALES HAVE NOT BEEN REMOVED PROPERLY

- DEGREASING TO REMOVE GREASE, CONTAMINATION AND OTHER FOREIGN MATTER
- 2. CHIPPING, WIRE-BRUSH AND WIPE WITH COTTON RAG TO ENSURE SURFACE IS FREE OF DUST, DEBRIS AND CLEAN
- 3. ZINGA IS TO BE SPRAYED FROM 4 TO 6 PASSES TO ACHIEVE THE REQUIRED THICKNESS OF 150 MICRONS

NO SHORT CUTS
MUST COMPLY
WITH MINIMUM
3 STEPS

OF SURFACE PREPARATION

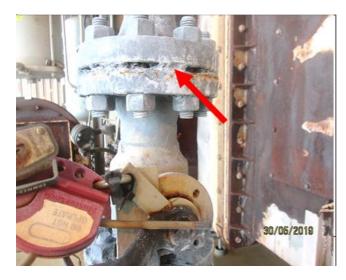
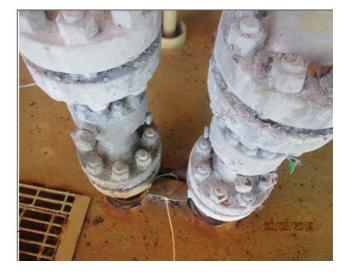
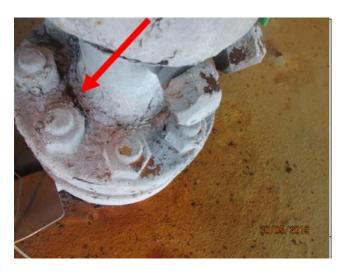
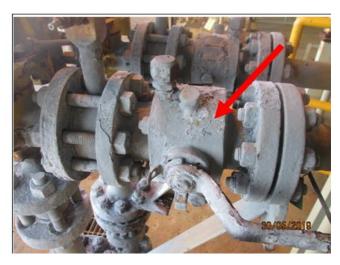
DESCRIPTION: ZINGA APPLICATION AS SHOWN BELOW IS NOT ADEQUATE — THE SURFACE PREPARATION IS NOT DONE TO A PROPER STANDARD SINCE LOOSE PAINT AND RUST

SCALES HAVE NOT BEEN REMOVED PROPERLY

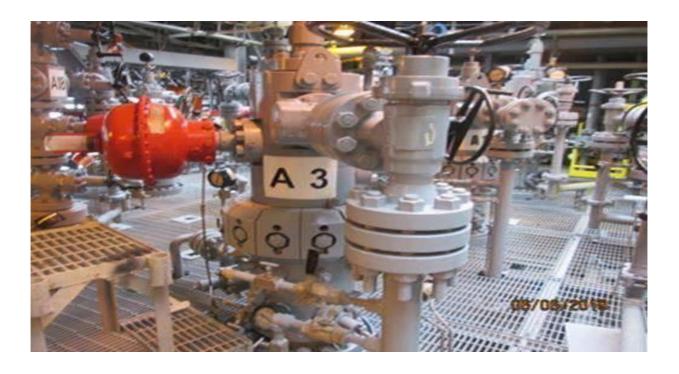
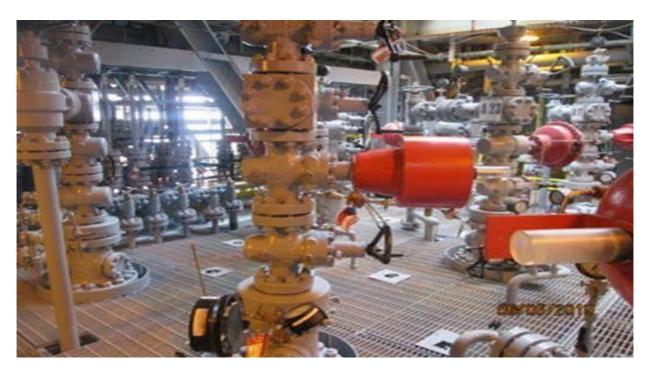
DESCRIPTION: VISUAL INSPECTION AT ONGOING WELLHEAD AREA FOUND

REMARKS BY PAINTING INSPECTOR: WORK DONE AT A SATISFACTORY LEVEL— AS PER

REQUIREMENT AND IS PRESENTABLE; QUALITY WORK MUST BE MAINTAINED

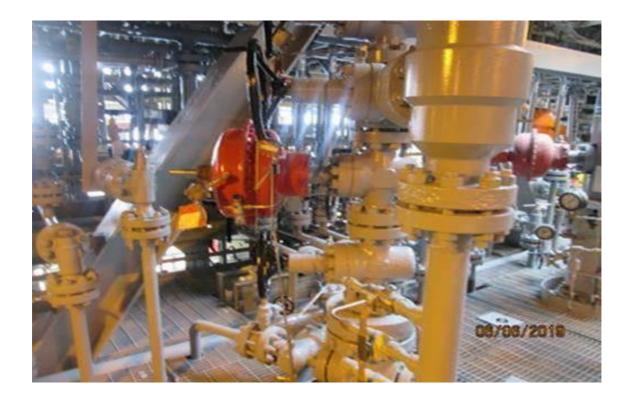
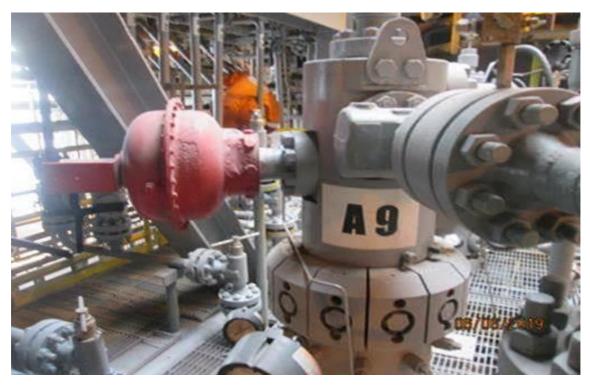
DESCRIPTION: VISUAL INSPECTION AT ONGOING WELLHEAD AREA FOUND

REMARKS BY PAINTING INSPECTOR: WORK DONE AT A SATISFACTORY LEVEL— AS PER

REQUIREMENT AND IS PRESENTABLE; QUALITY WORK MUST BE MAINTAINED
